The Deutsches Museum Spacesuit Display: Long-Term Preservation and Atmospheric Monitoring

Keywords: environmental corrosivity; air quality; monitoring; preservation; spacesuit

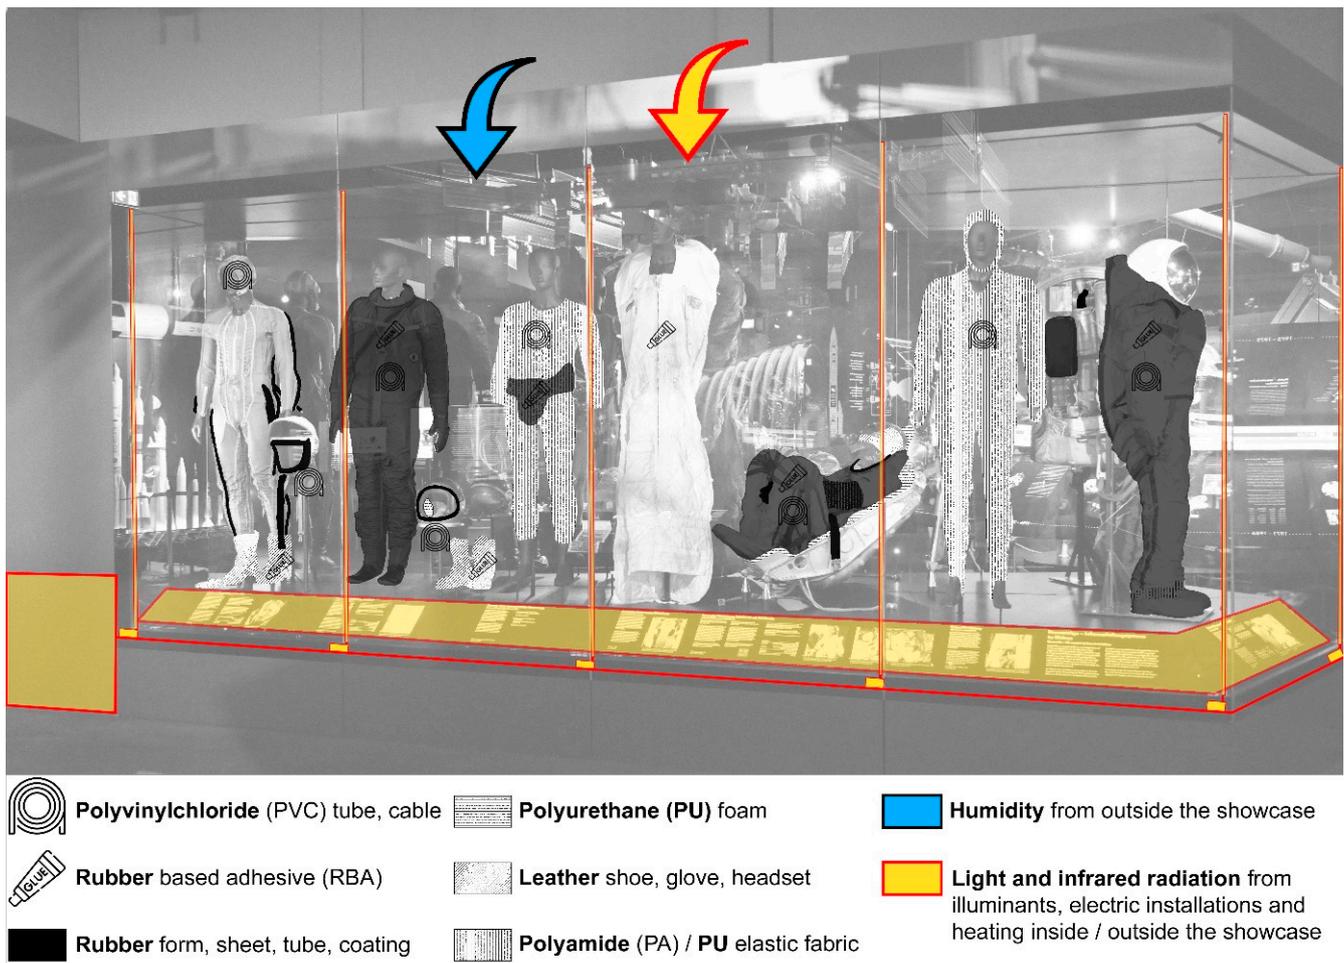
Figure 2. Sources of damaging factors in the exhibition from inside and outside the showcase with mapping of the most sensitive materials in spacesuits, PVC, RBA, rubber, PU, leather, PA, and PU. The arrows represent the influence of humidity and radiation respectively from outside the showcase.

The suits are made of a variety of synthetic materials, metals, and some natural fibers (Figure 2), highlighting the presence of those materials in the showcase that are known for their potential to produce off-gazing [15]: polyvinylchloride (PVC), rubber-based adhesives (RBA), rubber, polyurethane (PU), and leather. The Mark IV, Sokol-KV2, and Orlan-DM suit furthermore show a multi-layered structure, with air-tight rubber-coated polyamide (PA) fabrics on the inside, which is restrained with another fabric. This kind of layer buildup favors the accumulation of off-gazing inside the suits. In a previous work, the materials, manufacturing techniques, and preservation of the Sokol-KV2 pressure suit were identified. Grzywacz, C.M. [19] reports the source of pollutants in museums. Vulcanized rubber and rubber-based materials are known to produce H₂S, SO₂, COS, CS₂, and O₃. Other compounds such as PVC lead to organic acid formation. The presence of these polymeric materials explain the odor observed in the showroom, indicating that the main area of concern is consequently the presence of air pollutants in the form of off-gazing and contaminants, which interact with other parts in close proximity. Previous XPS investigations of coupons demonstrate the presence of sulfide on silver materials, in agreement with Holzer et al. [17].

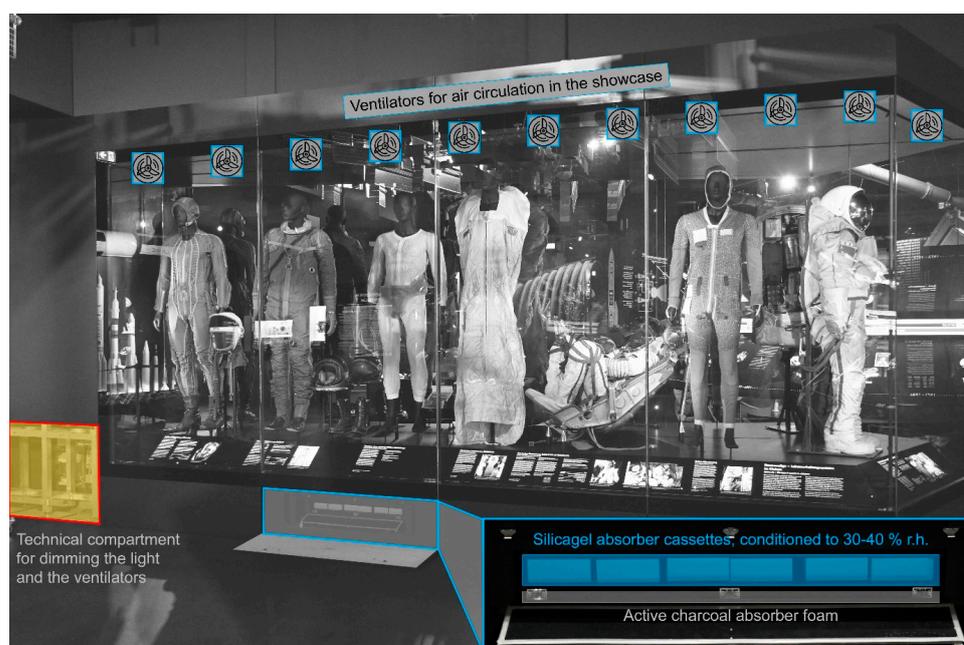
Figure 3. Absorbent materials in the showcase drawers to remove pollutants from the atmosphere (grey) and to buffer relative humidity (blue). See also the detail on the right. Control unit for the ventilators and dimming light on the left (yellow).

The renovated rooms were newly refurbished with inorganic building materials, such as metal or glass, but also with a variety of synthetic panels, adhesives, sealing, and MDF boards that also can emit pollutants such as organic acids and formaldehyde [30]. Inside the showcase, humidity and pollutant levels are controlled with silica gel and charcoal absorbers, respectively (Figure 3), which are detailed in Section 3.1.

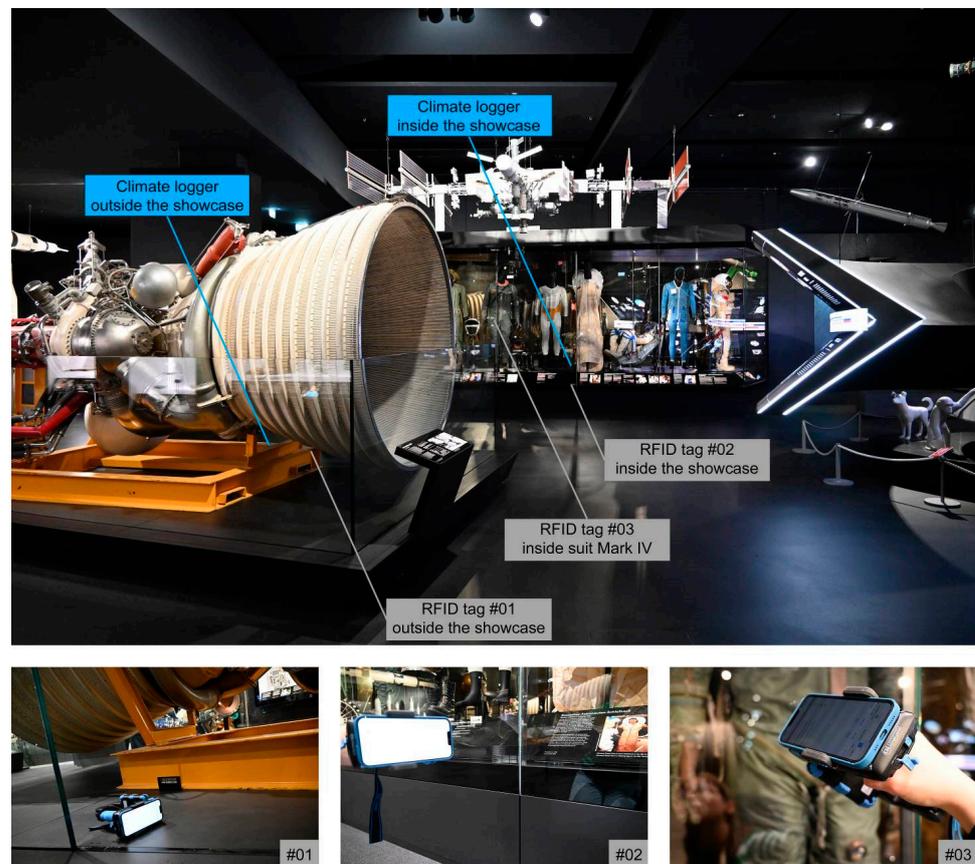
Figure 4. Location of the RFID tags #01–#03 and the climate logger in the exhibition (**above**) and the interrogation with the UHF-RFID reader at the three locations (**below**).

The choice of passive pollutant and humidity control also meant that a separate monitoring program needed to be installed. Figure 4 shows the locations of the RFID sensors in the rooms. Tag #01 is located outside the showroom, while tags #02 and #03 are inside to evaluate the atmosphere around the spacesuits. RFID tag #03 was positioned inside the pilot suit Mark IV, between the outer restraint layer (PA) and the inner bladder (PA coated with neoprene rubber) [32]. Tag #02 is located at about 1.5 m from tag #01. The sensors were put inside black 3D-printed containers, in order to reduce their visual nuisance in the museum. Note that prior to the exposure measurements, the suitability of these locations was determined by placing test antenna tags in situ and interrogating them by the selected portable RFID reader.

Over the five months of exposure, the sensors were interrogated weekly by the conservator, using the hand-held UHF-RFID reader. This device, shown in Figure 4, is connected to a smartphone and is placed during the interrogation at 30–40 cm in front of the tag. A major improvement of the method with respect to the first tests concerns the development of a specific mobile application. Some functionalities are depicted in Figure S1 of the Supplementary Material. As is seen, the application is used first to connect the mobile to the RFID reader by Bluetooth (Connect to the Reader). After this step, it is possible to detect the reference RFID tags responding in the close environment (Search for RFID Tags). To ensure a correct reading of the sensor, the reading distance has to be adjusted during this interrogation task to receive a RSSI value of the reference tag around -47 dBm. As shown in Figure S1 of the Supplementary Material, a green RSSI value on the phone indicates a correct interrogation phase. If the RSSI value is red, the reading distance has to be modified by the end-user. In the present case, one sensor is correctly interrogated, and not the two other ones. Since only a reference was observed on the application, corrosion of the metal thickness had not occurred. In the present case, it was possible to correctly interrogate the three sensors displayed at the bottom of Figure 4.

Tag #01 is close to a metallic object. This object could have an impact on the communication between the sensor and the reader. This was not observed, and the sensor was correctly interrogated during the whole period. Due to regular staff rotation, not every member of the museum guides and cleaning teams were informed about the ongoing research in the exhibition. Therefore, the location of the tag was changed during the test to a position where no further movement was possible. Interrogation of tags #02 and #03 was done through the glass of the showcase and so without removing the tag from inside the pilot suit. Interrogating such battery-less sensors at a typical distance of 50 cm during a very long exposure time is their main feature. Additional RFID sensors were tentatively positioned inside the showroom, and in particular in the drawer. However, due to the metallic shielding of the drawer, the communication between the tag and the reader was strongly reduced, leading to some difficulties during the interrogation task. This highlights the importance of providing RFID sensors well adapted to their locations. Work is currently in progress to provide RFID sensors less sensitive to the local environment. Embedding sensors in materials has for example been considered [33]. Table 4 identifies the tags and presents the results. No signal from the sensitive tag located outside the showcase (tag #01) was detected within the test phase duration of five months, indicating an ultra-low or low corrosive atmosphere (IC1 or IC2). This result can be connected to high-air-exchange rates in the exhibition through the ventilation system. Note that an ultra-low corrosivity class (IC1) can be attained at this location. Indeed, in this case, the metallic loss would be less than 16 nm/year, leading to a tag's detection after 9.3 months of exposure, a duration that was not reached in the present study. In the showroom, the tag #03 inside the pilot suit Mark IV was detected after 39 days, resulting in an IC3 level (medium corrosivity index). At about 1.5 m from the suit, an IC2 level (low corrosivity) was achieved, demonstrating a rapid decay of pollutant content, certainly due to the presence of absorbers in the showroom. This example highlights the interest of RFID sensors to identify the sources of pollutants in showrooms and more generally in museums. Other methods were applied in the past for similar tasks. M. Dubus et al. [34] used electrical resistance sensors in several museums to define the IC levels and thus the suitability of several showcases for conservation. In this case, similarly to the present study, the sensors were based on the chemical reactivity of metals such as silver or copper to pollutants. Other studies focused on the determination of the sources of gaseous pollutants in museums or archives by using sampling methods [35] or gas sensors [36]. The main differences between these previous studies and the present one is the ultra-low cost and low visual nuisance of RFID sensors.

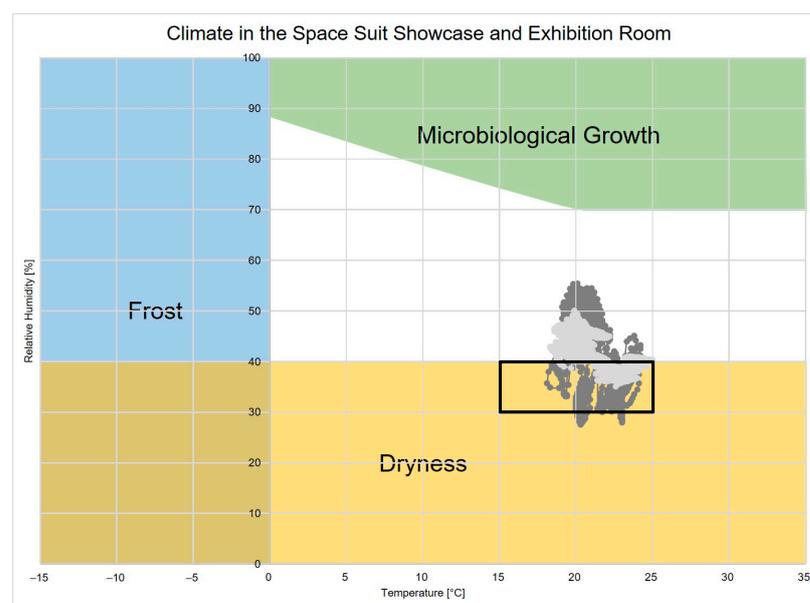
**Figure 5.** Results of the climate measurement from November 2022 to March 2023 inside (light grey) and outside (dark grey) of the spacesuit showcase. Target value marked with black frame.

As shown previously in Figure 4, climate loggers (testo[®] 174H devices, Testo SE & Co. KGaA, Titisee-Neustadt, Germany) were located inside and outside the showcase. Results are depicted in Figures 5 and 6. Only a slight fluctuation of relative humidity and temperature was observed within the enclosed space, thus demonstrating its protective functionality against climate changes from outside. The temperature was well within the required 15–25 °C in the whole exhibition area, with maximum daily fluctuations of ± 1 °C in the showcase. The relative humidity in the presentation room of the spacesuits was more influenced by changes in temperature than it follows the outside humidity levels (Figure 6) and evened out above 45% with $\pm 2\%$ fluctuations during the day. It can be concluded that the silica gels help to buffer the relative humidity, but are not efficient enough to dehumidify the atmosphere inside the showcase down to 30–40%. The observed temperature values are connected to museum opening times. Indeed, as shown in Figure 6, temperature and humidity change within a day. During closed days around Christmas and New Year, such daily variation disappeared. A likely explanation for that phenomenon is the lack of heat production from lighting and other electronics in the exhibition during those days. This is highlighted by the slightly higher temperature difference inside the showcase, which is caused by the internal lighting. Judging from this dataset, the pilot and spacesuits are displayed in an environment that can be characterized as climate class AA, according to the Canadian Conservation Institute. It has to be noted that seasonal changes can not yet be evaluated. There should be no or only small risk to mechanical damage induced by incorrect climate conditions and chemically unstable materials, such as rubber, PVC, PU, or PA, which will be unusable within decades [37].

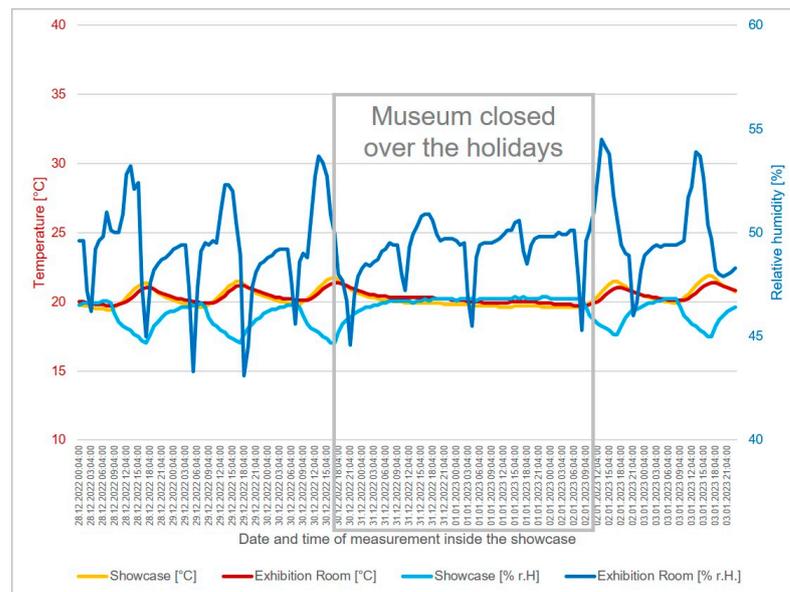
Figure 6. The climate inside and outside the spacesuit showcase over New Year's Day 2022/23. Data recorded in the exhibition room with a shift of 30 min from the shown time.

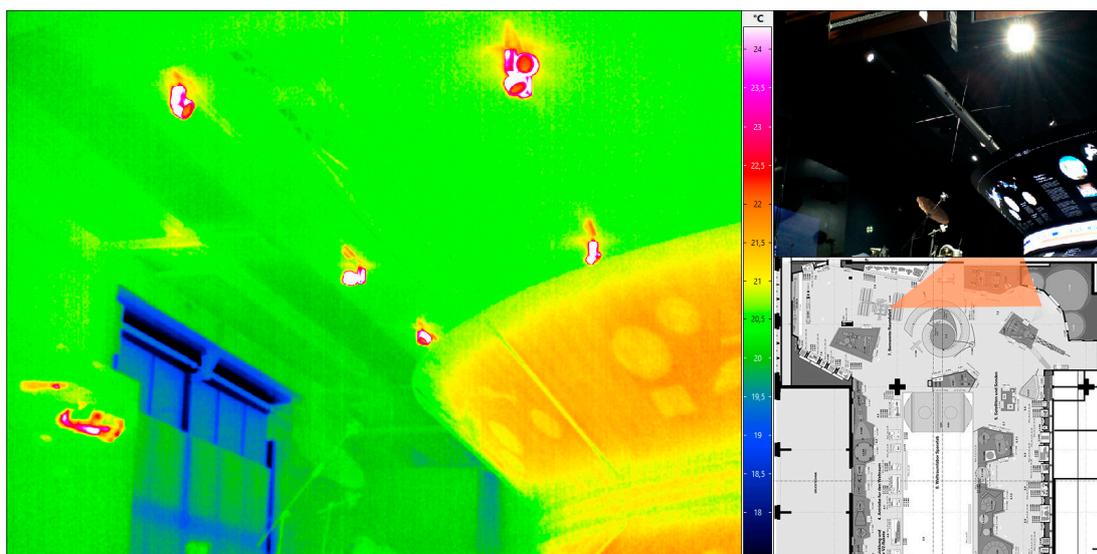
Figure 7. Infrared thermal image of the spacesuit showcase surrounding (left) with the location of the camera marked on the exhibition plan (below right): heating-cooling ceiling, installations, lighting, and a large portal. Image on the upper right shows the area in normal light.

In the exhibition “Astronautics”, there are two main sources of radiation: the lighting on the ceiling and inside the showcases as well as the heating-cooling panels on the ceiling (Figure 7). High-energy UV radiation was completely excluded from the surroundings of the spacesuits by forgoing daylight and choosing suitable warm light LED illuminants. The properties of these latter are provided in Table 5. The absence of UVA and UVB radiation (290–390 nm) was confirmed by punctual measurements (Voltcraft® UV 500, Conrad Electronic SE, Hirschau, Germany). The recommended levels of 30–100 lux of visible light (around 400–700 nm) were adjusted during the installation process. The whole outline of the objects as well as detailed structures, such as textile weave, small metal parts, or writing on mission patches, are readable to visitors of different age groups [6]. With a color rendering index (CRI) value above 95, the LEDs have an excellent color rendering capacity [29].
