# The Deutsches Museum Spacesuit Display: Long-Term Preservation and Atmospheric Monitoring

**Abstract:** Spacesuits are highly valuable artifacts made of sensitive synthetic materials, including rubber, polyvinylchloride, polyamide, or polyurethane. The main concerns for preservation are off-gazing from the objects themselves and the exterior agents of deterioration humidity, high temperature, UV radiation, and visible light. This study addresses the implementation of preventive conservation in the Deutsches Museum spacesuit display and the evaluation of the atmosphere with monitoring methods. The focus lies on innovative RFID corrosion sensors developed by the Lab-STICC and used in an exhibition for the first time. In addition, commercial devices (climate logger, UV and light meters, infrared thermal imaging) were used to check the conditions in the spacesuit showcase. The source for off-gazing coming from a suit could be located through the sensors, and the low corrosivity inside the showcase showed the effectivity of the installed charcoal absorbers. Humidity, however, was unable to be reduced to the recommended 30–40% in the large-scale showcase with silica gel. The LED light

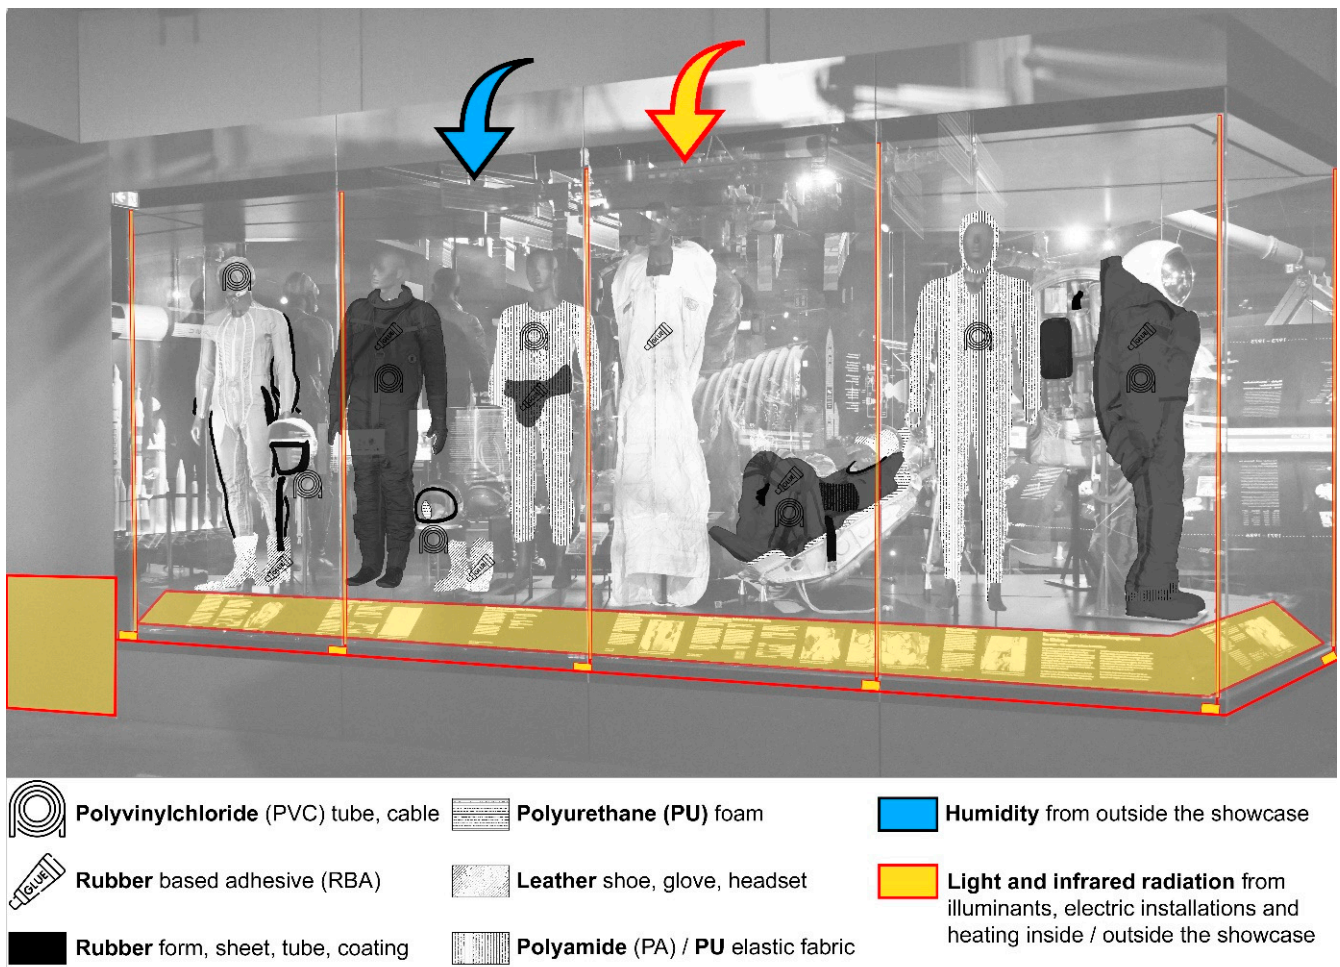
**Figure 2.** Sources of damaging factors in the exhibition from inside and outside the showcase with mapping of the most sensitive materials in spacesuits, PVC, RBA, rubber, PU, leather, PA, and PU. The arrows represent the influence of humidity and radiation respectively from outside the showcase.

The suits are made of a variety of synthetic materials, metals, and some natural fibers (Figure 2), highlighting the presence of those materials in the showcase that are known for their potential to produce off-gazing [15]: polyvinylchloride (PVC), rubber-based adhesives (RBA), rubber, polyurethane (PU), and leather. The Mark IV, Sokol-KV2, and Orlan-DM suit furthermore show a multi-layered structure, with air-tight rubber-coated polyamide (PA) fabrics on the inside, which is restrained with another fabric. This kind of layer buildup favors the accumulation of off-gazing inside the suits. In a previous work, the materials, manufacturing techniques, and preservation of the Sokol-KV2 pressure suit were identified. Grzywacz, C.M. [19] reports the source of pollutants in museums. Vulcanized rubber and rubber-based materials are known to produce H<sub>2</sub>S, SO<sub>2</sub>, COS, CS<sub>2</sub>, and O<sub>3</sub>. Other compounds such as PVC lead to organic acid formation. The presence of these polymeric materials explain the odor observed in the showroom, indicating that the main area of concern is consequently the presence of air pollutants in the form of off-gazing and contaminants, which interact with other parts in close proximity. Previous XPS investigations of coupons demonstrate the presence of sulfide on silver materials, in agreement with Holzer et al. [17].

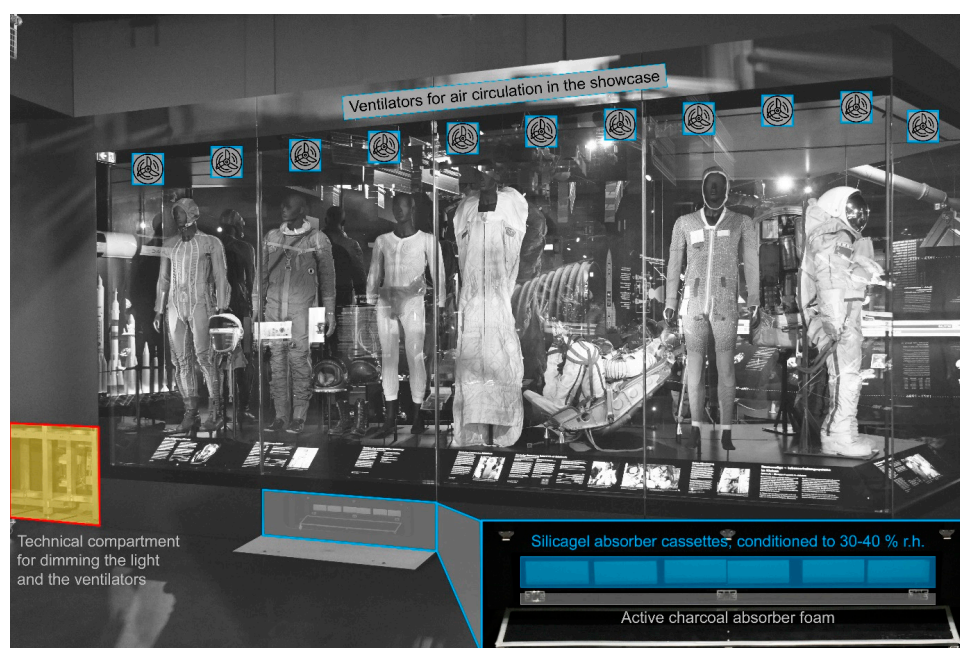
**Figure 3.** Absorbent materials in the showcase drawers to remove pollutants from the atmosphere (grey) and to buffer relative humidity (blue). See also the detail on the right. Control unit for the ventilators and dimming light on the left (yellow).

The renovated rooms were newly refurbished with inorganic building materials, such as metal or glass, but also with a variety of synthetic panels, adhesives, sealing, and MDF boards that also can emit pollutants such as organic acids and formaldehyde [30]. Inside the showcase, humidity and pollutant levels are controlled with silica gel and charcoal absorbers, respectively (Figure 3), which are detailed in Section 3.1.

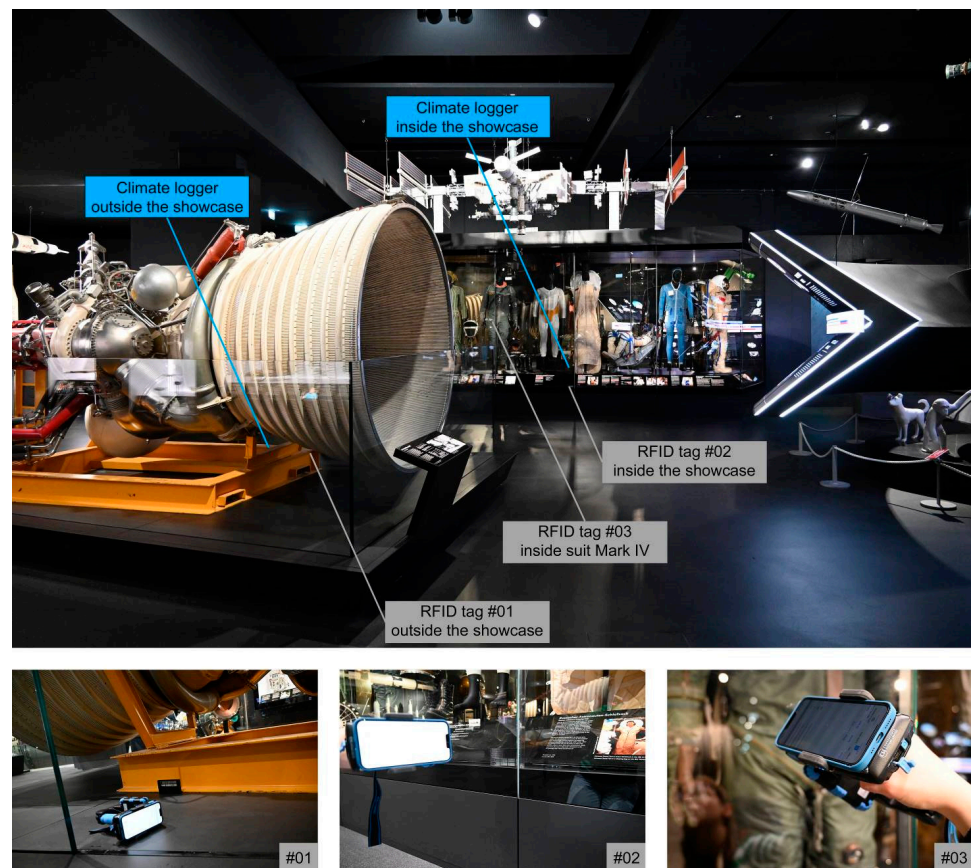
**Figure 4.** Location of the RFID tags #01–#03 and the climate logger in the exhibition (**above**) and the interrogation with the UHF-RFID reader at the three locations (**below**).

The choice of passive pollutant and humidity control also meant that a separate monitoring program needed to be installed. Figure 4 shows the locations of the RFID sensors in the rooms. Tag #01 is located outside the showroom, while tags #02 and #03 are inside to evaluate the atmosphere around the spacesuits. RFID tag #03 was positioned inside the pilot suit Mark IV, between the outer restraint layer (PA) and the inner bladder (PA coated with neoprene rubber) [32]. Tag #02 is located at about 1.5 m from tag #01. The sensors were put inside black 3D-printed containers, in order to reduce their visual nuisance in the museum. Note that prior to the exposure measurements, the suitability of these locations was determined by placing test antenna tags in situ and interrogating them by the selected portable RFID reader.

Over the five months of exposure, the sensors were interrogated weekly by the conservator, using the hand-held UHF-RFID reader. This device, shown in Figure 4, is connected to a smartphone and is placed during the interrogation at 30–40 cm in front of the tag. A major improvement of the method with respect to the first tests concerns the development of a specific mobile application. Some functionalities are depicted in Figure S1 of the Supplementary Material. As is seen, the application is used first to connect the mobile to the RFID reader by Bluetooth (Connect to the Reader). After this step, it is possible to detect the reference RFID tags responding in the close environment (Search for RFID Tags). To ensure a correct reading of the sensor, the reading distance has to be adjusted during this interrogation task to receive a RSSI value of the reference tag around  $-47$  dBm. As shown in Figure S1 of the Supplementary Material, a green RSSI value on the phone indicates a correct interrogation phase. If the RSSI value is red, the reading distance has to be modified by the end-user. In the present case, one sensor is correctly interrogated, and not the two other ones. Since only a reference was observed on the application, corrosion of the metal thickness had not occurred. In the present case, it was possible to correctly interrogate the three sensors displayed at the bottom of Figure 4.

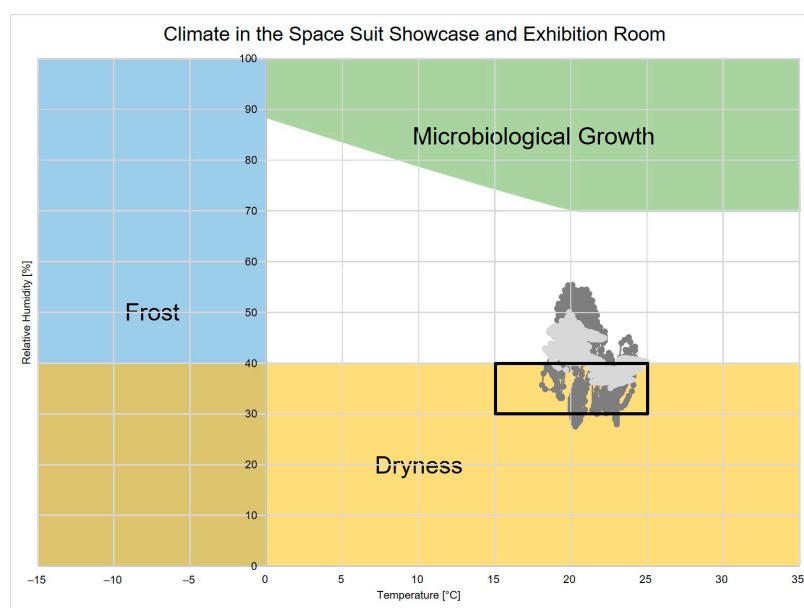
**Figure 5.** Results of the climate measurement from November 2022 to March 2023 inside (light grey) and outside (dark grey) of the spacesuit showcase. Target value marked with black frame.

As shown previously in Figure 4, climate loggers (testo<sup>®</sup> 174H devices, Testo SE & Co. KGaA, Titisee-Neustadt, Germany) were located inside and outside the showcase. Results are depicted in Figures 5 and 6. Only a slight fluctuation of relative humidity and temperature was observed within the enclosed space, thus demonstrating its protective functionality against climate changes from outside. The temperature was well within the required 15–25 °C in the whole exhibition area, with maximum daily fluctuations of  $\pm 1$  °C in the showcase. The relative humidity in the presentation room of the spacesuits was more influenced by changes in temperature than it follows the outside humidity levels (Figure 6) and evened out above 45% with  $\pm 2\%$  fluctuations during the day. It can be concluded that the silica gels help to buffer the relative humidity, but are not efficient enough to dehumidify the atmosphere inside the showcase down to 30–40%. The observed temperature values are connected to museum opening times. Indeed, as shown in Figure 6, temperature and humidity change within a day. During closed days around Christmas and New Year, such daily variation disappeared. A likely explanation for that phenomenon is the lack of heat production from lighting and other electronics in the exhibition during those days. This is highlighted by the slightly higher temperature difference inside the showcase, which is caused by the internal lighting. Judging from this dataset, the pilot and spacesuits are displayed in an environment that can be characterized as climate class AA, according to the Canadian Conservation Institute. It has to be noted that seasonal changes can not yet be evaluated. There should be no or only small risk to mechanical damage induced by incorrect climate conditions and chemically unstable materials, such as rubber, PVC, PU, or PA, which will be unusable within decades [37].

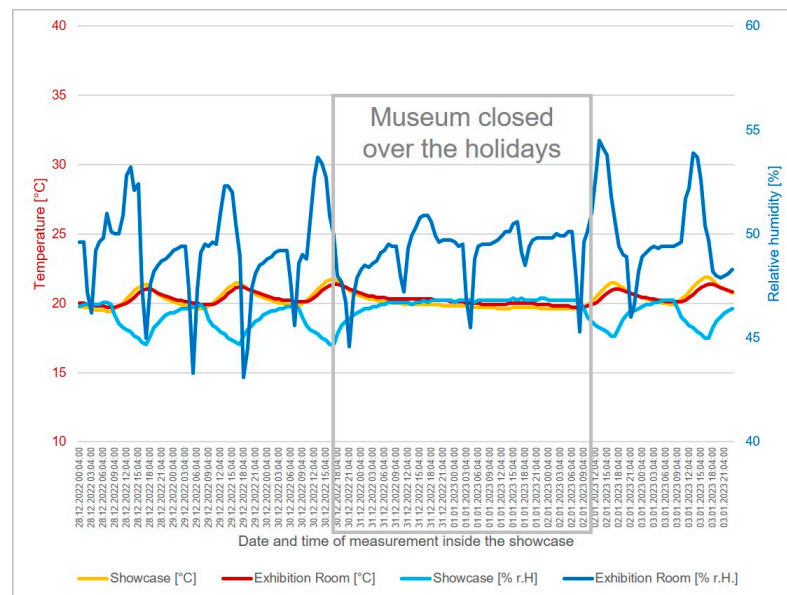
**Figure 6.** The climate inside and outside the spacesuit showcase over New Year's Day 2022/23. Data recorded in the exhibition room with a shift of 30 min from the shown time.

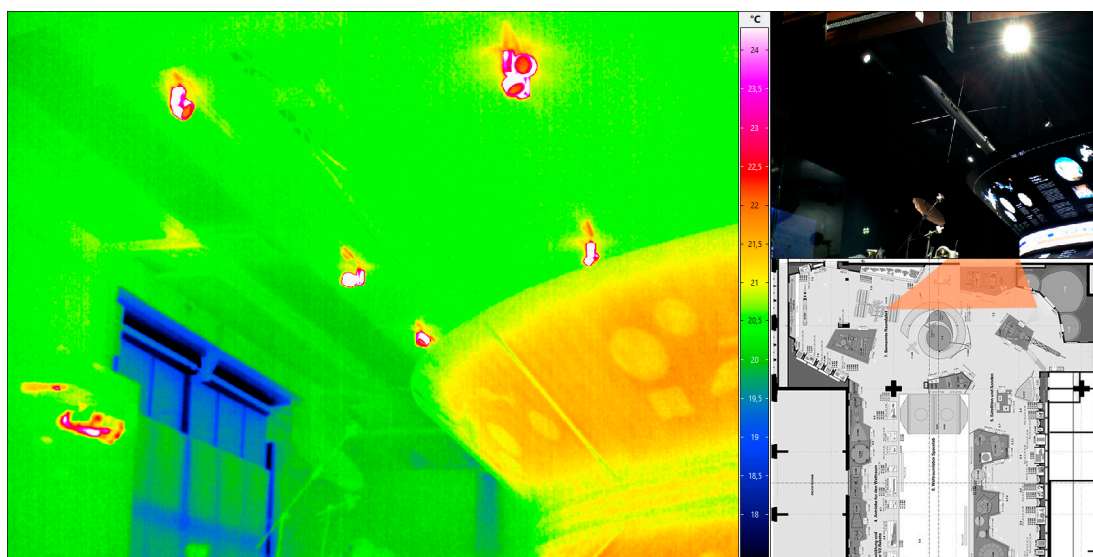
**Figure 7.** Infrared thermal image of the spacesuit showcase surrounding (left) with the location of the camera marked on the exhibition plan (below right): heating-cooling ceiling, installations, lighting, and a large portal. Image on the upper right shows the area in normal light.

In the exhibition “Astronautics”, there are two main sources of radiation: the lighting on the ceiling and inside the showcases as well as the heating-cooling panels on the ceiling (Figure 7). High-energy UV radiation was completely excluded from the surroundings of the spacesuits by forgoing daylight and choosing suitable warm light LED illuminants. The properties of these latter are provided in Table 5. The absence of UVA and UVB radiation (290–390 nm) was confirmed by punctual measurements (Voltcraft® UV 500, Conrad Electronic SE, Hirschau, Germany). The recommended levels of 30–100 lux of visible light (around 400–700 nm) were adjusted during the installation process. The whole outline of the objects as well as detailed structures, such as textile weave, small metal parts, or writing on mission patches, are readable to visitors of different age groups [6]. With a color rendering index (CRI) value above 95, the LEDs have an excellent color rendering capacity [29].
